**Flood Control Project Maintenance
Levee Inspections**
LMA District Cover Sheet
Spring 2014 Levee Inspection Results

San Joaquin County Flood Control and Water Conservation District

Spring 2014 Levee Inspection Results

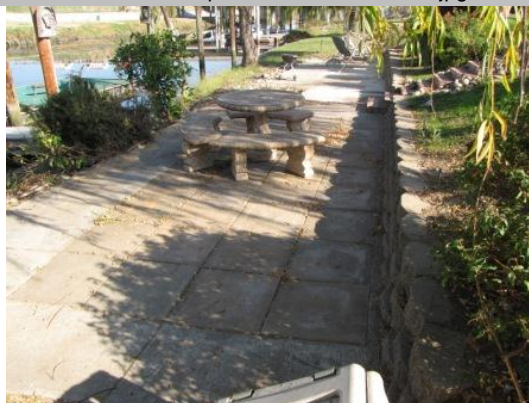
Photo 1 of 1 : pkazi_s_20140415_272.jpg

LM Start	0.83	Rating **	M	Issue No.	1080
LM End	0.84	Issue Type +	En	Location *	WS
Category	Earthen Levee			GPS Latitude/Longitude	
				Start	End
Item	Encroachments			38.053178 °	38.053178 °
				-121.375387 °	-121.375387 °
DWR ID	DWR_NA0017_08_s _ 2012_1080				
Action/Comments					
Building

View of a retaining wall and patio with furniture in the waterward toe and berm looking upstream.

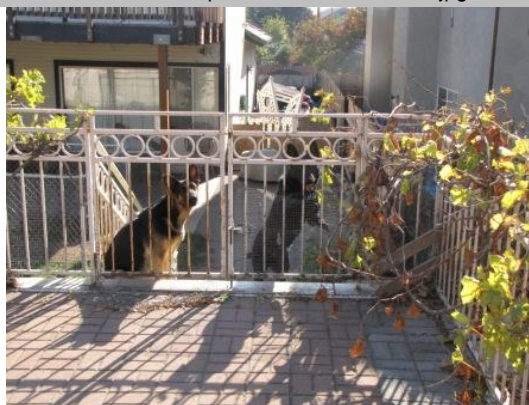
Photo 1 of 1 : pkazi_s_20140415_269.jpg

LM Start	0.83	Rating **	A/W	Issue No.	1078
LM End	0.83	Issue Type +	En	Location *	LS
Category	Earthen Levee			GPS Latitude/Longitude	
				Start	End
Item	Encroachments			38.053178 °	38.053178 °
				-121.375387 °	-121.375387 °
DWR ID	DWR_NA0017_08_s _ 2012_1078				
Action/Comments					
Stairway Inspector Comments: Stairs from patio down into yard. Large dogs prevented a close view.

View of steps on the landward slope and dogs preventing a closer inspection.

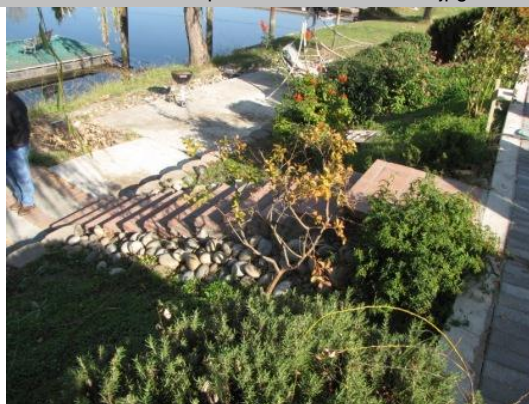
Photo 1 of 1 : pkazi_s_20140415_273.jpg

LM Start	0.84	Rating **	A/W	Issue No.	1081
LM End	0.84	Issue Type +	En	Location *	WS
Category	Earthen Levee			GPS Latitude/Longitude	
				Start	End
Item	Encroachments			38.053178 °	38.053178 °
				-121.375387 °	-121.375387 °
DWR ID	DWR_NA0017_08_s _ 2012_1081				
Action/Comments					
Stairway Inspector Comments: Stairs on waterward slope.

View of steps on the waterward slope of the levee looking upstream.

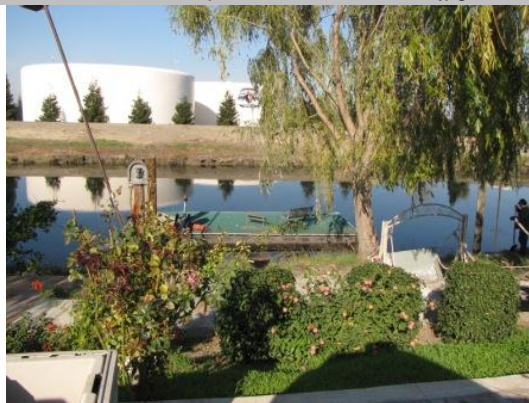
Photo 1 of 1 : pkazi_s_20140415_274.jpg

LM Start	0.84	Rating **	M	Issue No.	1082
LM End	0.84	Issue Type +	En	Location *	WS
Category	Earthen Levee			GPS Latitude/Longitude	
				Start	End
Item	Encroachments			38.053178 °	38.053178 °
				-121.375387 °	-121.375387 °
DWR ID	DWR_NA0017_08_s _ 2012_1082				
Action/Comments					
Building					
Inspector Comments: Dock on waterward side of berm.

View of a dock on the waterward side of the berm.

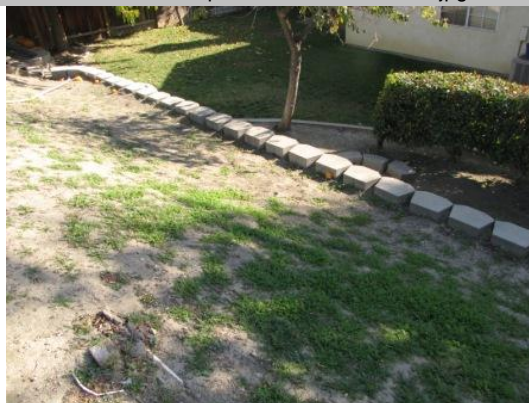
Photo 1 of 1 : pkazi_s_20140415_275.jpg

LM Start	0.84	Rating **	M	Issue No.	1083
LM End	0.85	Issue Type +	En	Location *	LS
Category	Earthen Levee			GPS Latitude/Longitude	
				Start	End
Item	Encroachments			38.053178 °	38.053178 °
				-121.375387 °	-121.375387 °
DWR ID	DWR_NA0017_08_s _ 2012_1083				
Action/Comments					
Building					
Inspector Comments: Retaining wall into the landward toe. Some irrigation is still present but landscaping on the slope is not there.

View of a retaining wall in the landward slope.

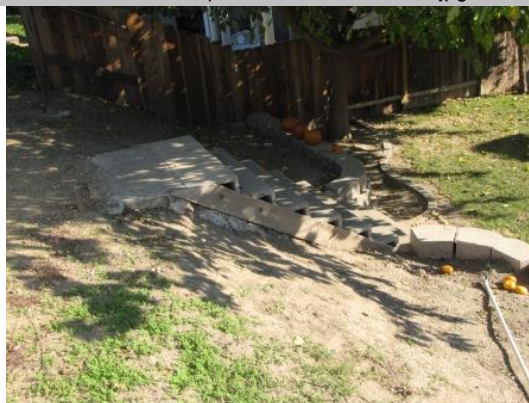
Photo 1 of 1 : pkazi_s_20140415_276.jpg

LM Start	0.85	Rating **	A/W	Issue No.	1085
LM End	0.85	Issue Type +	En	Location *	LS
Category	Earthen Levee			GPS Latitude/Longitude	
				Start	End
Item	Encroachments			38.053178 °	38.053178 °
				-121.375387 °	-121.375387 °
DWR ID	DWR_NA0017_08_s _ 2012_1085				
Action/Comments					
Stairway

View of steps on the landward slope looking upstream.

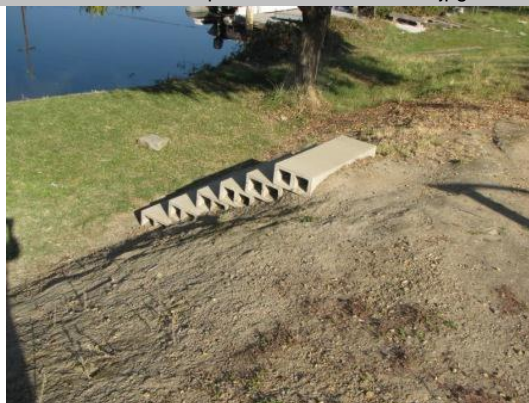
Photo 1 of 1 : pkazi_s_20140415_277.jpg

LM Start	0.85	Rating **	A/W	Issue No.	1086
LM End	0.85	Issue Type +	En	Location *	WS
Category	Earthen Levee			GPS Latitude/Longitude	
				Start	End
Item	Encroachments			38.053178 °	38.053178 °
				-121.375387 °	-121.375387 °
DWR ID	DWR_NA0017_08_s_2012_1086				
Action/Comments					
Stairway

View of steps on the waterward slope looking upstream.

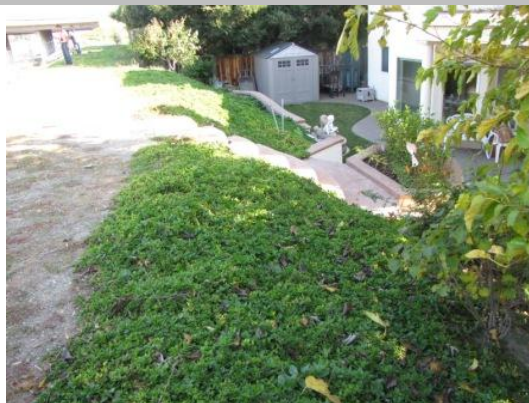
Photo 1 of 2 : pkazi_s_20140415_278.jpg

LM Start	0.85	Rating **	U	Issue No.	1087
LM End	0.87	Issue Type +	En	Location *	LS
Category	Earthen Levee			GPS Latitude/Longitude	
				Start	End
Item	Vegetation			38.053178 °	38.053178 °
				-121.375387 °	-121.375387 °
DWR ID	DWR_NA0017_08_s_2012_1087				
Action/Comments					
Landscaping					
Inspector Comments: Landscaping and irrigation on the landward slope.

View of landscaping and irrigation on the landward slope looking upstream.

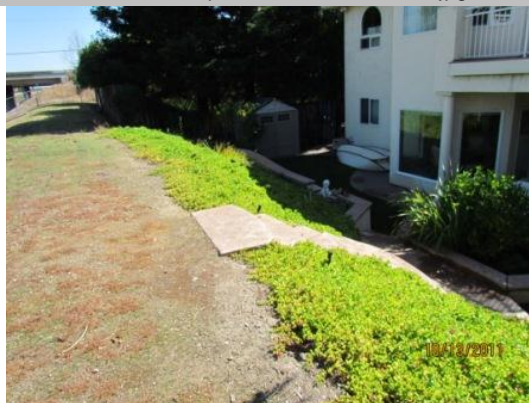
Photo 2 of 2 : pkazi_s_20140415_279.jpg

LM Start	0.85	Rating **	U	Issue No.	1087 (cont)
LM End	0.87	Issue Type +	En	Location *	LS

View of landscaping on the landside of the levee looking upstream. This picture was taken during fall 2011 inspection.

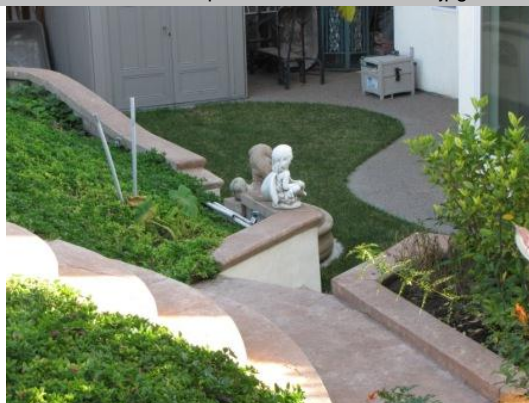
Photo 1 of 1 : pkazi_s_20140415_280.jpg

LM Start	0.85	Rating **	M	Issue No.	1088
LM End	0.87	Issue Type +	En	Location *	LS
Category	Earthen Levee			GPS Latitude/Longitude	
				Start	End
Item	Encroachments			38.053178 °	38.053178 °
				-121.375387 °	-121.375387 °
DWR ID	DWR_NA0017_08_s _ 2012_1088				
Action/Comments					
Building

View of a retaining wall and patio in the landward slope.

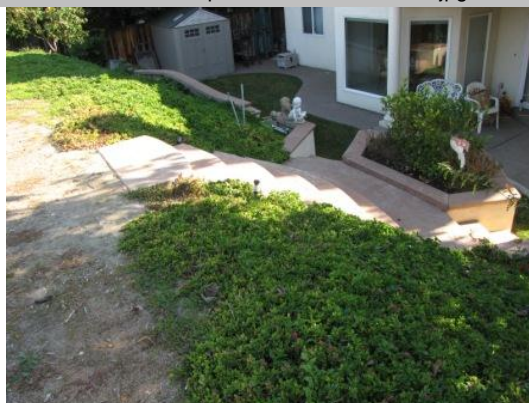
Photo 1 of 1 : pkazi_s_20140415_281.jpg

LM Start	0.86	Rating **	A/W	Issue No.	1089
LM End	0.86	Issue Type +	En	Location *	LS
Category	Earthen Levee			GPS Latitude/Longitude	
				Start	End
Item	Encroachments			38.053178 °	38.053178 °
				-121.375387 °	-121.375387 °
DWR ID	DWR_NA0017_08_s _ 2012_1089				
Action/Comments					
Stairway

View of steps on the landward slope looking upstream.

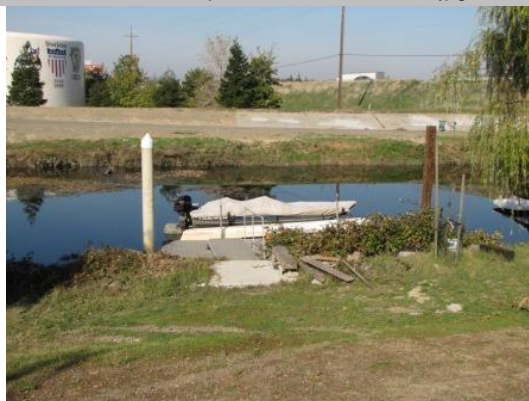
Photo 1 of 1 : pkazi_s_20140415_282.jpg

LM Start	0.86	Rating **	M	Issue No.	1090
LM End	0.86	Issue Type +	En	Location *	WS
Category	Earthen Levee			GPS Latitude/Longitude	
				Start	End
Item	Encroachments			38.053178 °	38.053178 °
				-121.375387 °	-121.375387 °
DWR ID	DWR_NA0017_08_s _ 2012_1090				
Action/Comments					
Building					
Inspector Comments: Dock on waterward side of berm with patio on berm.

View of a dock and concrete pad on the waterward side of the berm.

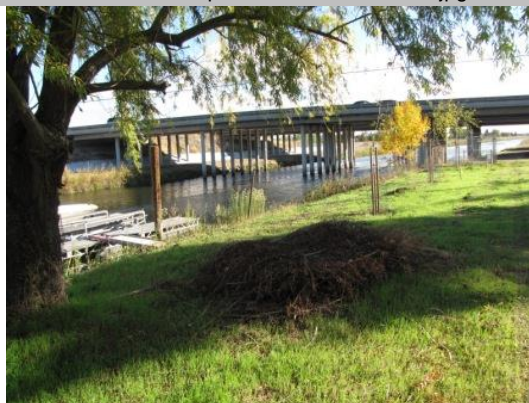
Photo 1 of 1 : pkazi_s_20140415_180.jpg

LM Start	0.87	Rating **	M	Issue No.	2
LM End	0.87	Issue Type +	Ma	Location *	WS
Category	Earthen Levee			GPS Latitude/Longitude	
				Start	End
Item	Encroachments			38.043093 °	38.043093 °
				-121.368860 °	-121.368860 °
DWR ID	DWR_NA0017_08_s_2012_2				
Action/Comments					
Prunings Inspector Comments: Landowner dumping prunings and clippings on the waterward side of the levee.

View of a prunings pile on the waterward berm looking upstream.

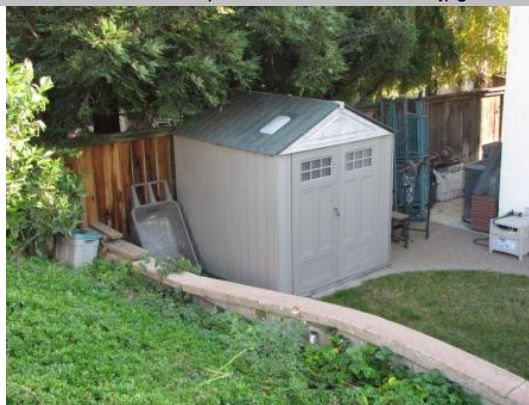
Photo 1 of 1 : pkazi_s_20140415_283.jpg

LM Start	0.87	Rating **	M	Issue No.	1091
LM End	0.87	Issue Type +	En	Location *	LS
Category	Earthen Levee			GPS Latitude/Longitude	
				Start	End
Item	Encroachments			38.053178 °	38.053178 °
				-121.375387 °	-121.375387 °
DWR ID	DWR_NA0017_08_s_2012_1091				
Action/Comments					
Building Inspector Comments: Shed at the landward toe.

View of a shed located at the landward toe looking upstream.

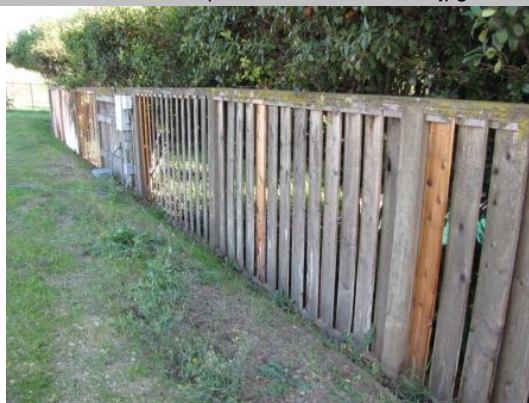
Photo 1 of 1 : pkazi_s_20140415_284.jpg

LM Start	0.87	Rating **	U	Issue No.	1092
LM End	0.88	Issue Type +	En	Location *	LS
Category	Earthen Levee			GPS Latitude/Longitude	
				Start	End
Item	Encroachments			38.053178 °	38.053178 °
				-121.375387 °	-121.375387 °
DWR ID	DWR_NA0017_08_s_2012_1092				
Action/Comments					
Fence					
Inspector Comments: Fence on shoulder with an electrical panel and irrigation blocking visibility and access of/to the landward slope and toe. There appear to be some encroachments beyond including landscaping and a pool.

View of a fence at the landward shoulder blocking visibility and access looking upstream. Some encroachments can be seen through the fence but not with any detail. Also visible is an electrical panel and hose bib.

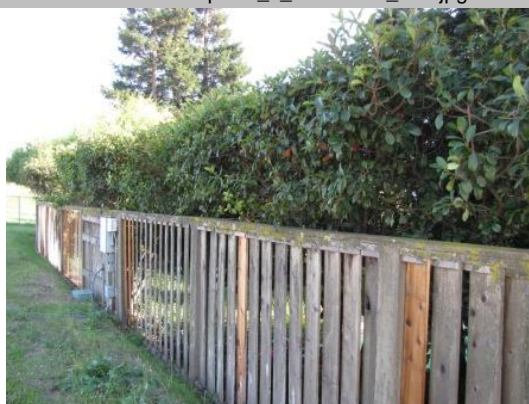
Photo 1 of 1 : pkazi_s_20140415_285.jpg

LM Start	0.87	Rating **	U	Issue No.	1093
LM End	0.88	Issue Type +	En	Location *	LS
Category	Earthen Levee			GPS Latitude/Longitude	
				Start	End
Item	Vegetation			38.053178 °	38.053178 °
				-121.375387 °	-121.375387 °
DWR ID	DWR_NA0017_08_s_2012_1093				
Action/Comments					
Landscaping Inspector Comments: Bushes growing above and behind wood fence further obstructing visibility and access.

View of bushes above the fence at the landward shoulder further obstructing visibility looking upstream.

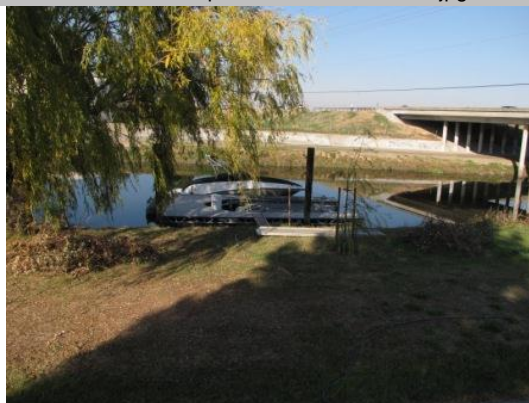
Photo 1 of 1 : pkazi_s_20140415_286.jpg

LM Start	0.88	Rating **	U	Issue No.	1094
LM End	0.88	Issue Type +	En	Location *	WS
Category	Earthen Levee			GPS Latitude/Longitude	
				Start	End
Item	Encroachments			38.053178 °	38.053178 °
				-121.375387 °	-121.375387 °
DWR ID	DWR_NA0017_08_s _ 2012_1094				
Action/Comments					
Building Inspector Comments: Dock on waterward side of berm.

View of a dock on the waterward side of the berm.

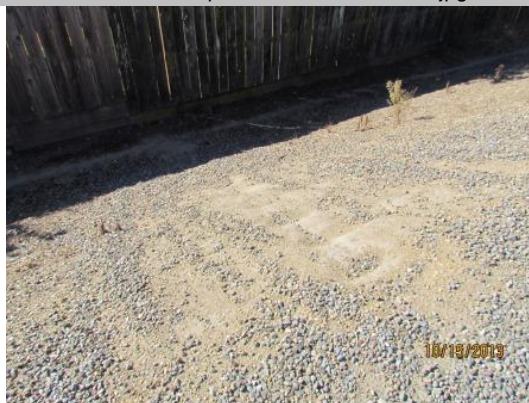
Photo 1 of 1 : pkazi_s_20140415_195.jpg

LM Start	1.31	Rating **	M	Issue No.	31
LM End	1.31	Issue Type +	Ma	Location *	LS
Category	Earthen Levee			GPS Latitude/Longitude	
				Start	End
Item	Encroachments			38.042894 °	38.042894 °
				-121.360467 °	-121.360467 °
DWR ID	DWR_NA0017_08_f_2013_31				
Action/Comments					
Stairway

Steps were dug on the landside slope of the levee looking downstream.

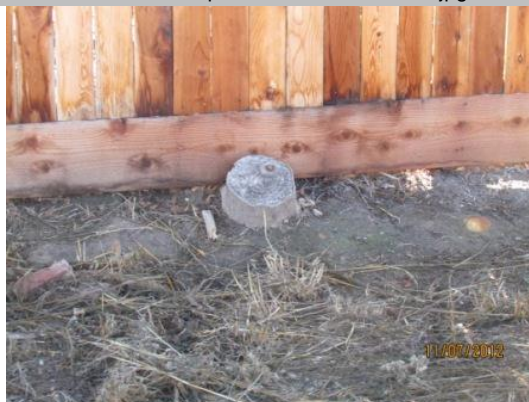
Photo 1 of 1 : pkazi_s_20140415_189.jpg

LM Start	1.73	Rating **	N	Issue No.	18
LM End	1.73	Issue Type +	Ma	Location *	LS
Category	Earthen Levee			GPS Latitude/Longitude	
				Start	End
Item	Trim / Thin Trees			38.042751 °	38.042751 °
				-121.353062 °	-121.353062 °
DWR ID	DWR_NA0017_08_f_2012_18				
Action/Comments					
Tree stumps.

A tree stump was found on the landside toe of the levee. The picture was taken from the crown looking towards the toe.

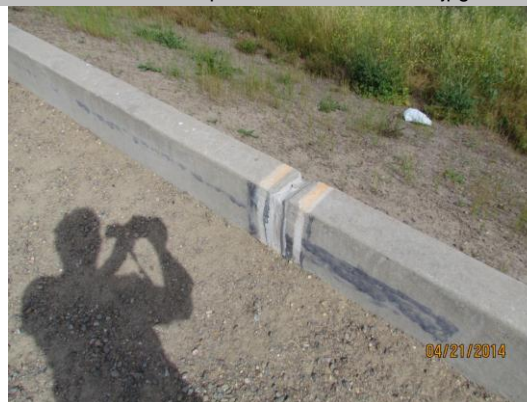
Photo 1 of 1 : pkazi_s_20140428_877.jpg

LM Start	1.83	Rating **	A	Issue No.	16
LM End	1.83	Issue Type +	Ma	Location *	WS
Category	Concrete Floodwalls			GPS Latitude/Longitude	
				Start	End
Item	Monolith Joints			38.042713 °	38.042713 °
				-121.351122 °	-121.351122 °
DWR ID	DWR_NA0017_08_s_2014_16				
Action/Comments					
Inspector Comments: The LMA has repaired the monolith joint at this location.

Monolith Joints at this location was repaired by the LMA. The picture was taken from the crown looking downstream.

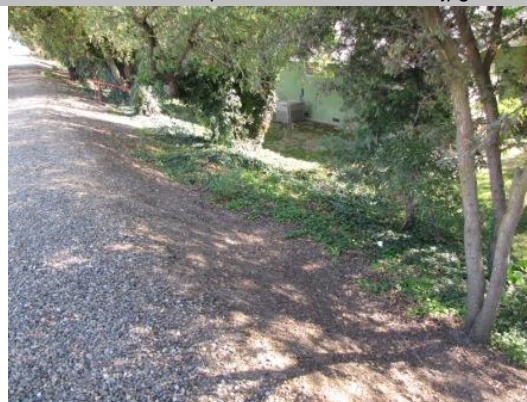
Photo 1 of 1 : pkazi_s_20140415_234.jpg

LM Start	2.04	Rating **	M	Issue No.	1006
LM End	2.07	Issue Type +	En	Location *	LS
Category	Earthen Levee			GPS Latitude/Longitude	
				Start	End
Item	Vegetation			38.042746 °	38.042803 °
				-121.347335 °	-121.346812 °
DWR ID	DWR_NA0017_08_s_2012_1006				
Action/Comments					
Landscaping					
Inspector Comments: Ivy and oleanders on landward slope.

View of landscaping along the landward slope looking upstream. County crews have greatly reduced the amount of material and increased visibility and access.

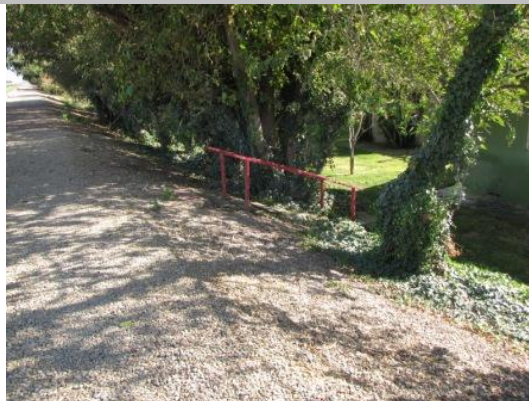
Photo 1 of 1 : pkazi_s_20140415_235.jpg

LM Start	2.06	Rating **	M	Issue No.	1007
LM End	2.06	Issue Type +	Ma	Location *	LS
Category	Earthen Levee			GPS Latitude/Longitude	
				Start	End
Item	Encroachments			38.042805 °	38.042805 °
				-121.347071 °	-121.347071 °
DWR ID	DWR_NA0017_08_s _ 2012_1007				
Action/Comments					
Stairway Inspector Comments: Steps were removed but the hand rails still exists at the location.

View of steps dug into the landward slope looking upstream.

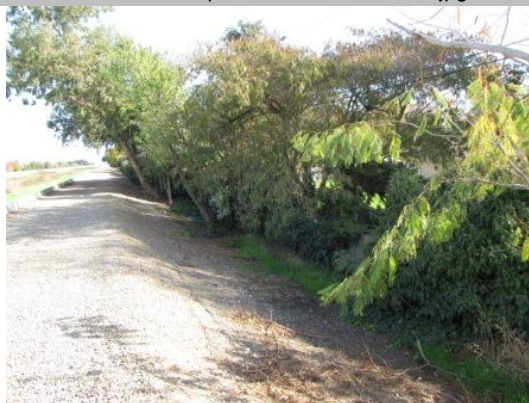
Photo 1 of 1 : pkazi_s_20140415_236.jpg

LM Start	2.11	Rating **	U	Issue No.	1008
LM End	2.14	Issue Type +	En	Location *	LS
Category	Earthen Levee			GPS Latitude/Longitude	
				Start	End
Item	Encroachments			38.042797 °	38.042787 °
				-121.346087 °	-121.345608 °
DWR ID	DWR_NA0017_08_s _ 2012_1008				
Action/Comments					
Fence Inspector Comments: The fence is covered by ivy.

View of a fence with landscaping growing on it at the landward toe looking upstream.

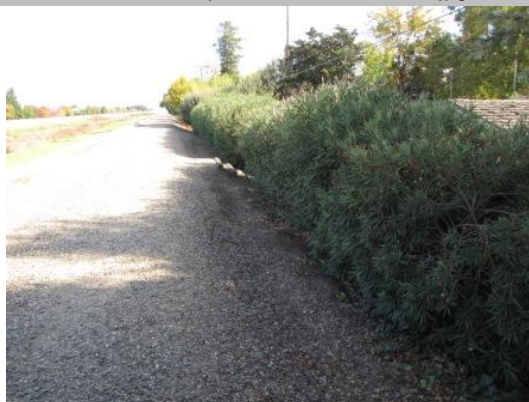
Photo 1 of 1 : pkazi_s_20140415_237.jpg

LM Start	2.14	Rating **	M	Issue No.	1009
LM End	2.16	Issue Type +	En	Location *	LS
Category	Earthen Levee			GPS Latitude/Longitude	
				Start	End
Item	Vegetation			38.042786 °	38.042779 °
				-121.345607 °	-121.345154 °
DWR ID	DWR_NA0017_08_s _ 2012_1009				
Action/Comments					
Landscaping

View of landscaping along the landward slope looking upstream.

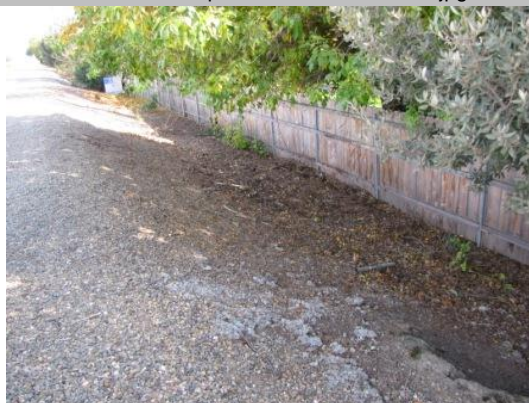
Photo 1 of 1 : pkazi_s_20140415_238.jpg

LM Start	2.17	Rating **	U	Issue No.	1011
LM End	2.19	Issue Type +	En	Location *	LS
Category	Earthen Levee			GPS Latitude/Longitude	
				Start	End
Item	Encroachments			38.042779 °	38.042775 °
				-121.345119 °	-121.344777 °
DWR ID	DWR_NA0017_08_s _ 2012_1011				
Action/Comments					
Fence					
Inspector Comments: Wood fence on landward toe.

View of a fence along the landward toe looking upstream.

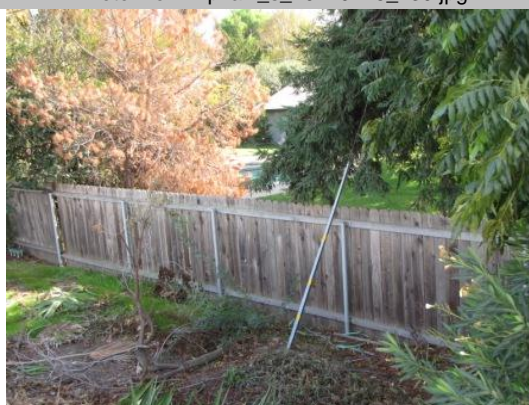
Photo 1 of 2 : pkazi_s_20140415_239.jpg

LM Start	2.19	Rating **	U	Issue No.	1012
LM End	2.25	Issue Type +	En	Location *	LS
Category	Earthen Levee			GPS Latitude/Longitude	
				Start	End
Item	Encroachments			38.042775 °	38.042773 °
				-121.344777 °	-121.343691 °
DWR ID	DWR_NA0017_08_s _ 2012_1012				
Action/Comments					
Fence					
Inspector Comments: Wood fence on landward toe.

View of a fence along the landward toe looking upstream.

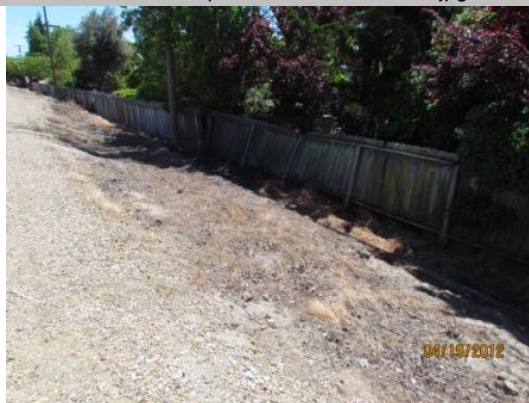
Photo 2 of 2 : pkazi_s_20140415_240.jpg

LM Start	2.19	Rating **	U	Issue No.	1012 (cont)
LM End	2.25	Issue Type +	En	Location *	LS

Fence was located on the landside toe of the levee looking upstream.
This picture was taken during spring 2012 inspection.

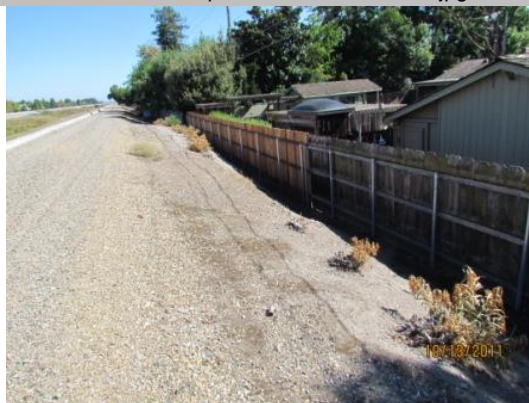
Photo 1 of 2 : pkazi_s_20140415_242.jpg

LM Start	2.25	Rating **	U	Issue No.	1018
LM End	2.30	Issue Type +	En	Location *	LS
Category	Earthen Levee			GPS Latitude/Longitude	
				Start	End
Item	Encroachments			38.042764 °	38.042765 °
				-121.343690 °	-121.342620 °
DWR ID	DWR_NA0017_08_s _ 2012_1018				
Action/Comments					
Fence					
Inspector Comments: Wood fence on the landward slope.

View of the fence on the landside toe of the levee looking upstream.
This picture was taken during fall 2011 inspection.

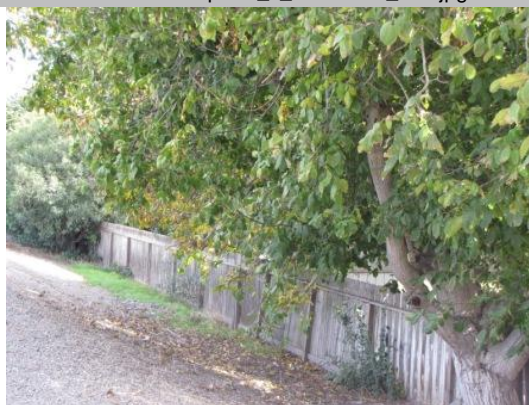
Photo 2 of 2 : pkazi_s_20140415_241.jpg

LM Start	2.25	Rating **	U	Issue No.	1018 (cont)
LM End	2.30	Issue Type +	En	Location *	LS

View of a wood fence at the landward toe.

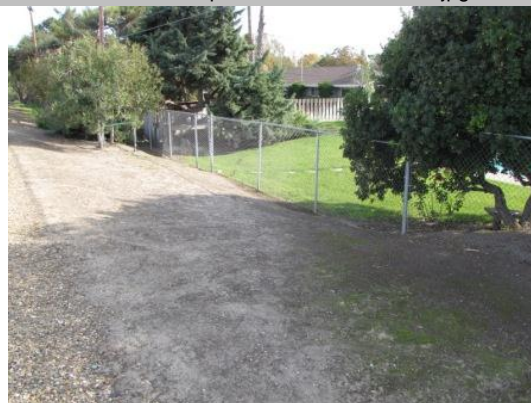
Photo 1 of 1 : pkazi_s_20140415_243.jpg

LM Start	2.30	Rating **	M	Issue No.	1021
LM End	2.38	Issue Type +	En	Location *	LS
Category	Earthen Levee			GPS Latitude/Longitude	
				Start	End
Item	Encroachments			38.042765 °	38.042760 °
				-121.342620 °	-121.341167 °
DWR ID	DWR_NA0017_08_s _ 2012_1021				
Action/Comments					
Fence					
Inspector Comments: Chain link fence on landward slope.

View of a fence on the landward slope looking upstream.

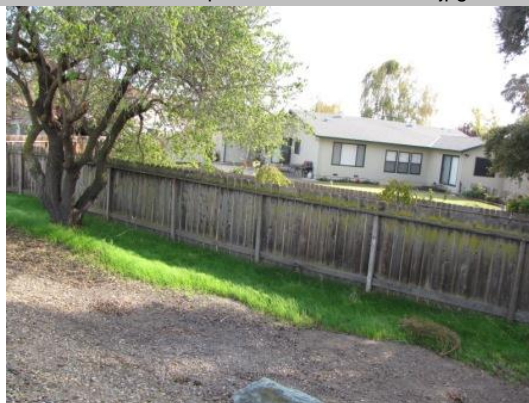
Photo 1 of 1 : pkazi_s_20140415_244.jpg

LM Start	2.38	Rating **	M	Issue No.	1023
LM End	2.40	Issue Type +	En	Location *	LS
Category	Earthen Levee			GPS Latitude/Longitude	
				Start	End
Item	Encroachments			38.042761 °	38.042767 °
				-121.341166 °	-121.340867 °
DWR ID	DWR_NA0017_08_s_2012_1023				
Action/Comments					
Fence					
Inspector Comments: Wood fence on landward slope.

View of a fence at the landward toe.

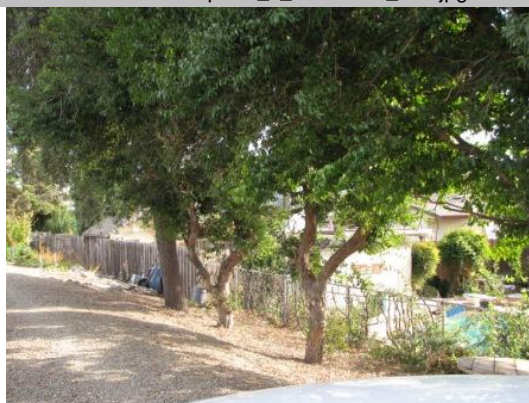
Photo 1 of 1 : pkazi_s_20140415_245.jpg

LM Start	2.40	Rating **	M	Issue No.	1024
LM End	2.43	Issue Type +	En	Location *	LS
Category	Earthen Levee			GPS Latitude/Longitude	
				Start	End
Item	Encroachments			38.042764 °	38.042751 °
				-121.340865 °	-121.340480 °
DWR ID	DWR_NA0017_08_s_2012_1024				
Action/Comments					
Fence

View of a fence at the landward toe.

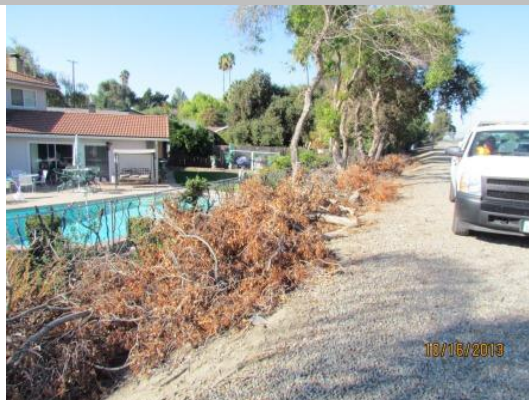
Photo 1 of 1 : pkazi_s_20140415_203.jpg

LM Start	2.43	Rating **	M	Issue No.	43
LM End	2.43	Issue Type +	En	Location *	LS
Category	Earthen Levee			GPS Latitude/Longitude	
				Start	End
Item	Encroachments			38.042756 °	38.042756 °
				-121.340599 °	-121.340599 °
DWR ID	DWR_NA0017_08_f_2013_43				
Action/Comments					
Prunings

Prunings were found on the landside toe of the levee looking downstream.

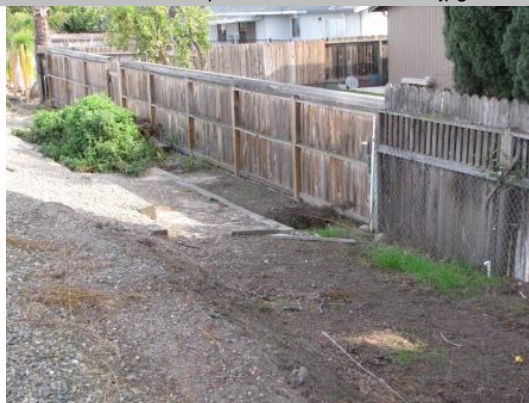
Photo 1 of 1 : pkazi_s_20140415_246.jpg

LM Start	2.43	Rating **	U	Issue No.	1026
LM End	2.69	Issue Type +	En	Location *	LS
Category	Earthen Levee			GPS Latitude/Longitude	
				Start	End
Item	Encroachments			38.042752 °	38.042717 °
				-121.340479 °	-121.335738 °
DWR ID	DWR_NA0017_08_s_2012_1026				
Action/Comments					
Fence					
Inspector Comments: Wood fence along landward slope.

View of a fence at the landward toe looking upstream.

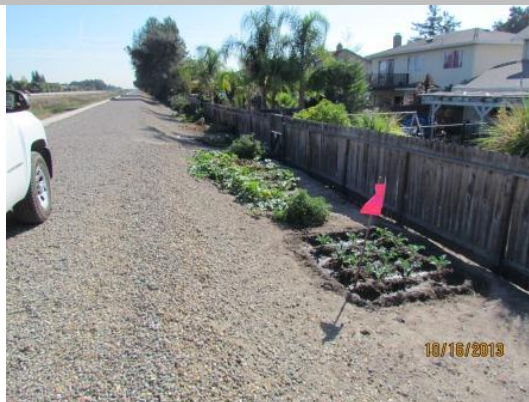
Photo 1 of 1 : pkazi_s_20140415_209.jpg

LM Start	2.47	Rating **	M	Issue No.	50
LM End	2.47	Issue Type +	En	Location *	LS
Category	Earthen Levee			GPS Latitude/Longitude	
				Start	End
Item	Vegetation			38.042752 °	38.042752 °
				-121.339773 °	-121.339773 °
DWR ID	DWR_NA0017_08_f_2013_50				
Action/Comments					
Landscaping

Landscaping was found on the landside toe of the levee looking upstream.

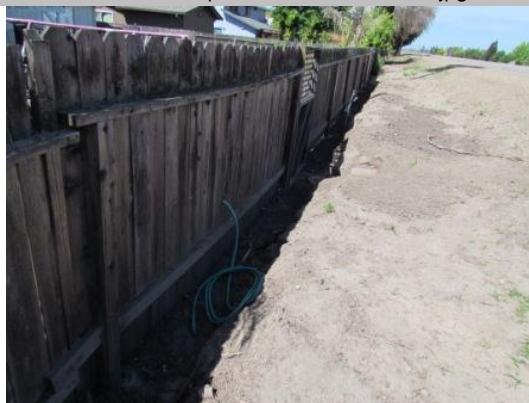
Photo 1 of 2 : pkazi_s_20140415_201.jpg

LM Start	2.48	Rating **	M	Issue No.	42
LM End	2.48	Issue Type +	En	Location *	LS
Category	Earthen Levee			GPS Latitude/Longitude	
				Start	End
Item	Encroachments			38.042744 °	38.042744 °
				-121.339671 °	-121.339671 °
DWR ID	DWR_NA0017_08_s _ 2012_42				
Action/Comments					
Ditch

The owner excavated a ditch on the toe at the landside of the levee. The picture was taken from the landside of the levee looking downstream.

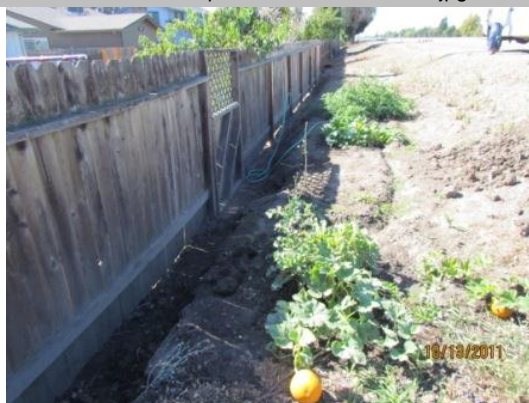
Photo 2 of 2 : pkazi_s_20140415_202.jpg

LM Start	2.48	Rating **	M	Issue No.	42 (cont)
LM End	2.48	Issue Type +	En	Location *	LS

View of a ditch at the landside toe of the levee looking downstream.

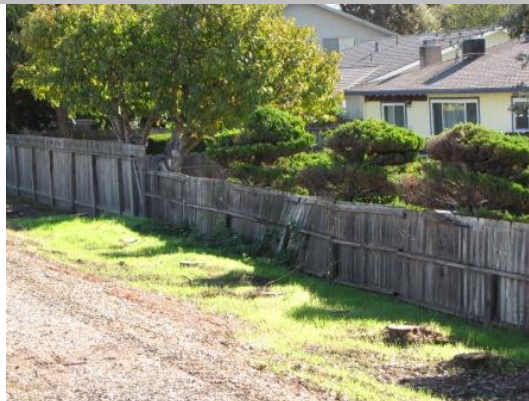
Photo 1 of 1 : pkazi_s_20140415_184.jpg

LM Start	2.55	Rating **	N	Issue No.	12
LM End	2.55	Issue Type +	Ma	Location *	LS
Category	Earthen Levee			GPS Latitude/Longitude	
				Start	End
Item	Trim / Thin Trees			38.042743 °	38.042743 °
				-121.338343 °	-121.338343 °
DWR ID	DWR_NA0017_08_s _ 2012_12				
Action/Comments					
Tree stumps.

View of stumps along the landward toe looking upstream.

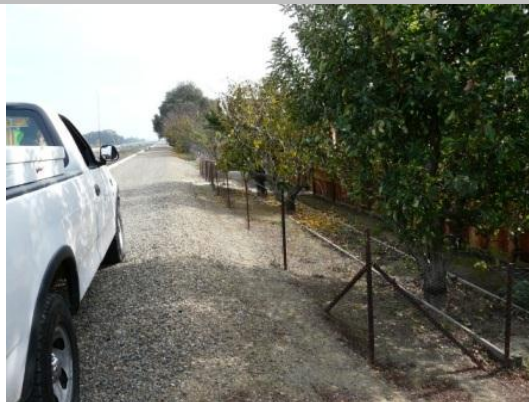
Photo 1 of 1 : pkazi_s_20140415_200.jpg

LM Start	2.58	Rating **	M	Issue No.	39
LM End	2.61	Issue Type +	En	Location *	LS
Category	Earthen Levee			GPS Latitude/Longitude	
				Start	End
Item	Encroachments			38.042718 °	38.042713 °
				-121.337506 °	-121.337074 °
DWR ID	DWR_NA0017_08_s _ 2012_39				
Action/Comments					
Fence

Fence located on sholder of landside of levee from LM 2.58 to LM 2.61

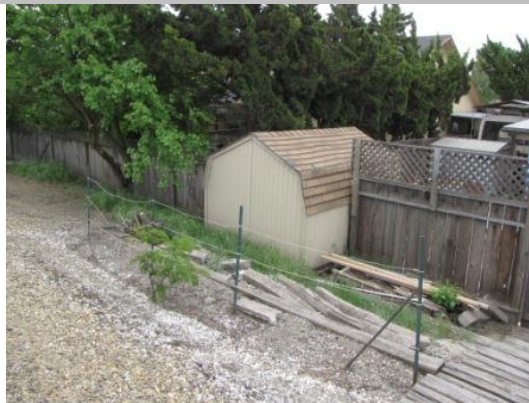
Photo 1 of 1 : pkazi_s_20140415_233.jpg

LM Start	2.61	Rating **	U	Issue No.	963
LM End	2.61	Issue Type +	En	Location *	LS
Category	Earthen Levee			GPS Latitude/Longitude	
				Start	End
Item	Encroachments			38.042724 °	38.042724 °
				-121.337075 °	-121.337075 °
DWR ID	DWR_NA0017_08_s _ 2012_963				
Action/Comments					
Building Inspector Comments: Fall 2010: Landscaping removed, but shed still exists.

Landscaping and shed placed on landward levee slope and within 10' of the toe.

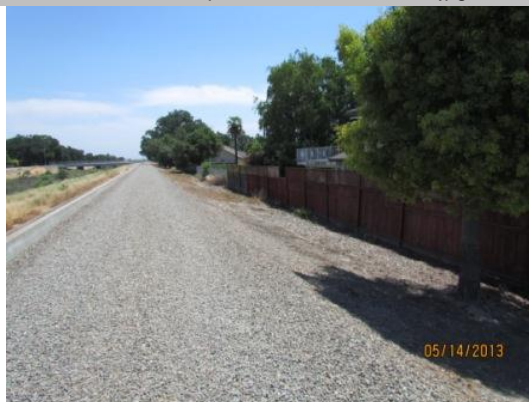
Photo 1 of 1 : pkazi_s_20140415_247.jpg

LM Start	2.77	Rating **	M	Issue No.	1040
LM End	2.82	Issue Type +	En	Location *	LS
Category	Earthen Levee			GPS Latitude/Longitude	
				Start	End
Item	Encroachments			38.042715 °	38.042714 °
				-121.334295 °	-121.333564 °
DWR ID	DWR_NA0017_08_s_2012_1040				
Action/Comments					
Fence					
Inspector Comments: Fence on landward toe.

Fence was found on the landside toe of the levee looking upstream.

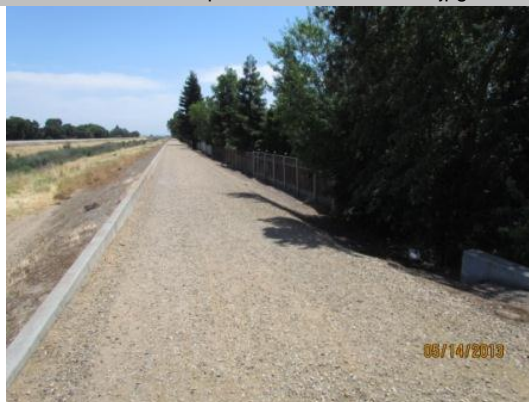
Photo 1 of 1 : pkazi_s_20140415_229.jpg

LM Start	2.93	Rating **	M	Issue No.	937
LM End	3.41	Issue Type +	En	Location *	LS
Category	Earthen Levee			GPS Latitude/Longitude	
				Start	End
Item	Encroachments			38.042696 °	38.042658 °
				-121.331553 °	-121.322930 °
DWR ID	DWR_NA0017_08_s _ 2012_937				
Action/Comments					
Fence

Fence was found on the landside toe of the levee looking upstream.

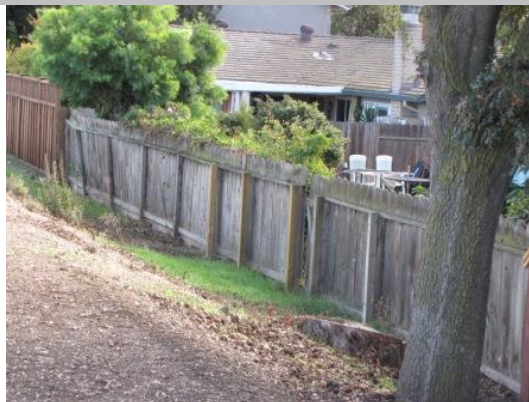
Photo 1 of 1 : pkazi_s_20140415_185.jpg

LM Start	3.08	Rating **	N	Issue No.	13
LM End	3.08	Issue Type +	Ma	Location *	LS
Category	Earthen Levee			GPS Latitude/Longitude	
				Start	End
Item	Trim / Thin Trees			38.042624 °	38.042624 °
				-121.328781 °	-121.328781 °
DWR ID	DWR_NA0017_08_s _ 2012_13				
Action/Comments					
Tree stumps.

View of a stump on the landward slope looking upstream.

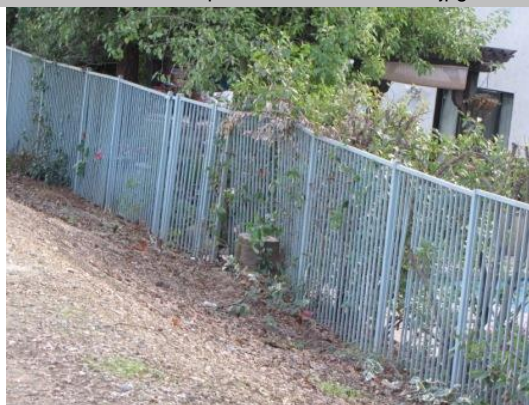
Photo 1 of 1 : pkazi_s_20140415_186.jpg

LM Start	3.15	Rating **	N	Issue No.	14
LM End	3.15	Issue Type +	Ma	Location *	LS
Category	Earthen Levee			GPS Latitude/Longitude	
				Start	End
Item	Trim / Thin Trees			38.042638 °	38.042638 °
				-121.327479 °	-121.327479 °
DWR ID	DWR_NA0017_08_s_2012_14				
Action/Comments					
Tree stumps.

View of a stump on the landward slope looking upstream.

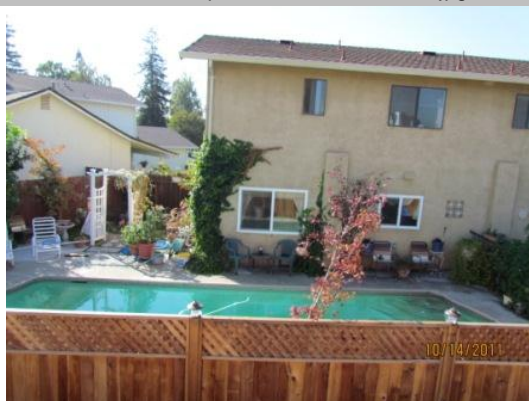
Photo 1 of 1 : pkazi_s_20140415_230.jpg

LM Start	3.15	Rating **	M	Issue No.	938
LM End	3.15	Issue Type +	En	Location *	LS
Category	Earthen Levee			GPS Latitude/Longitude	
				Start	End
Item	Encroachments			38.042658 °	38.042658 °
				-121.327418 °	-121.327418 °
DWR ID	DWR_NA0017_08_s_2012_938				
Action/Comments					
Pool					
Inspector Comments: Pool is constructed within 10 feet toe of the levee.

View of the pool located within 10 feet from the toe of the landside of the levee. The picture was taken from the crown looking towards the toe.

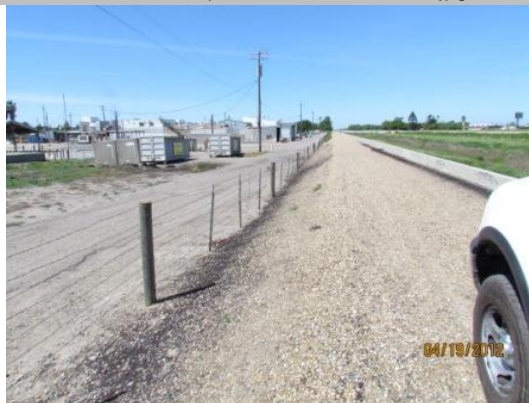
Photo 1 of 1 : pkazi_s_20140415_188.jpg

LM Start	3.56	Rating **	M	Issue No.	17
LM End	3.72	Issue Type +	En	Location *	LS
Category	Earthen Levee			GPS Latitude/Longitude	
				Start	End
Item	Encroachments			38.042598 °	38.042596 °
				-121.320107 °	-121.317354 °
DWR ID	DWR_NA0017_08_s_2012_17				
Action/Comments					
Fence Inspector Comments: Wood and metal post barbed wire fence at the landward toe.

A fence was found on the landside toe of the levee looking downstream.

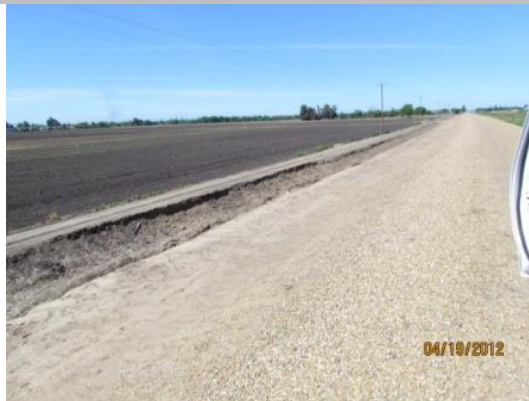
Photo 1 of 1 : pkazi_s_20140415_190.jpg

LM Start	4.15	Rating **	M	Issue No.	20
LM End	4.66	Issue Type +	En	Location *	LS
Category	Earthen Levee			GPS Latitude/Longitude	
				Start	End
Item	Encroachments			38.042490 °	38.042838 °
				-121.309742 °	-121.300586 °
DWR ID	DWR_NA0017_08_s _ 2012_20				
Action/Comments					
Ditch

An agricultural ditch was found on the landside of the levee looking downstream.

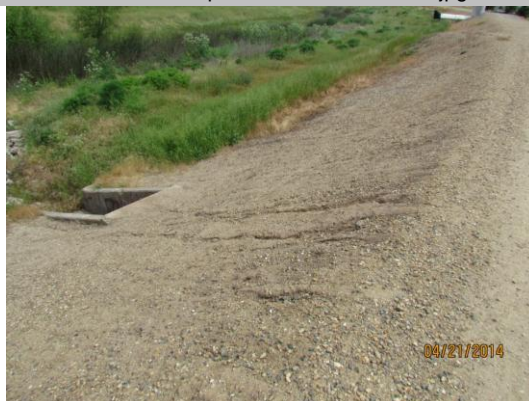
Photo 1 of 1 : pkazi_s_20140428_879.jpg

LM Start	4.64	Rating **	M	Issue No.	27
LM End	4.64	Issue Type +	Ma	Location *	WS
Category	Earthen Levee			GPS Latitude/Longitude	
				Start	End
Item	Erosion / Bank Caving			38.042728 °	38.042728 °
				-121.300923 °	-121.300923 °
DWR ID	DWR_NA0017_08_s _ 2014_27				
Action/Comments					
Schedule repair of erosion site prior to the next inspection. Inspector Comments: Ruts on the waterside slope of the levee.

Erosion caused by runoffs on the waterside slope of the levee looking upstream.

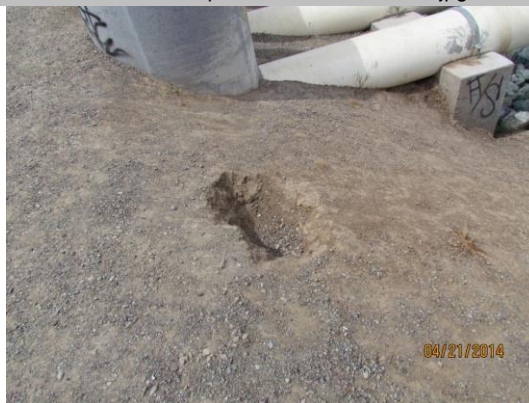
Photo 1 of 1 : pkazi_s_20140428_880.jpg

LM Start	4.68	Rating **	M	Issue No.	46
LM End	4.68	Issue Type +	Ma	Location *	WS
Category	Earthen Levee			GPS Latitude/Longitude	
				Start	End
Item	Slope Stability			38.043078 °	38.043078 °
				-121.300166 °	-121.300166 °
DWR ID	DWR_NA0017_08_s _ 2014_46				
Action/Comments					
Repair slope instability.

A slope instability was found on the waterside of the levee looking downstream.

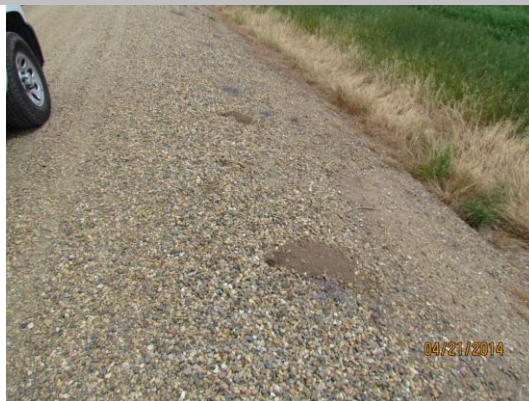
Photo 1 of 1 : pkazi_s_20140428_881.jpg

LM Start	6.65	Rating **	M	Issue No.	52
LM End	6.65	Issue Type +	Ma	Location *	LS
Category	Earthen Levee			GPS Latitude/Longitude	
				Start	End
Item	Animal Control			38.053109 °	38.053109 °
				-121.269818 °	-121.269818 °
DWR ID	DWR_NA0017_08_s _ 2014_52				
Action/Comments					
No rodents visible, but rodent burrows visible; need to backfill and

A rodent hole was found on the landside of the levee looking upstream.

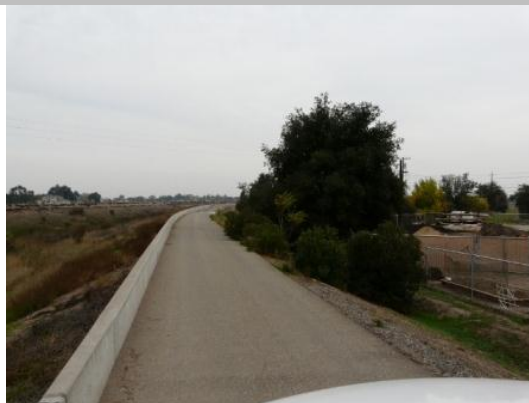
Photo 1 of 1 : pkazi_s_20140415_210.jpg

LM Start	7.57	Rating **	M	Issue No.	54
LM End	7.62	Issue Type +	En	Location *	LS
Category	Earthen Levee			GPS Latitude/Longitude	
				Start	End
Item	Vegetation			38.061125 °	38.061611 °
				-121.258760 °	-121.258137 °
DWR ID	DWR_NA0017_08_s_2012_54				
Action/Comments					
Landscaping

Landscaping along landside slope of levee from LM 7.57 to 7.62

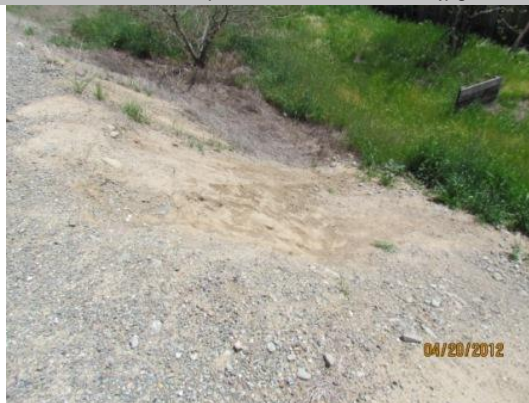
Photo 1 of 2 : pkazi_s_20140415_207.jpg

LM Start	7.65	Rating **	M	Issue No.	49
LM End	7.65	Issue Type +	Ma	Location *	LS
Category	Earthen Levee			GPS Latitude/Longitude	
				Start	End
Item	Slope Stability			38.061985 °	38.061985 °
				-121.257531 °	-121.257531 °
DWR ID	DWR_NA0017_08_s_2012_49				
Action/Comments					
Repair the levee slope damaged by foot traffic and prevent access where possible.

Erosion was found on the landside of the levee looking upstream.

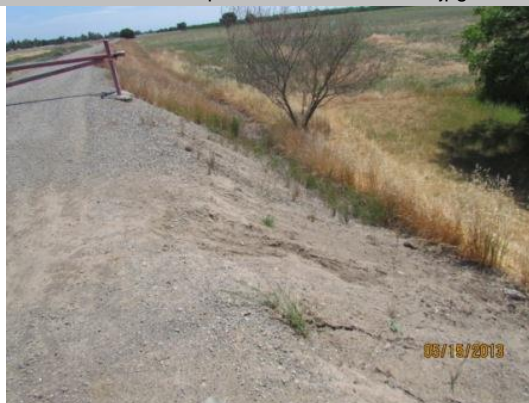
Photo 2 of 2 : pkazi_s_20140415_208.jpg

LM Start	7.65	Rating **	M	Issue No.	49 (cont)
LM End	7.65	Issue Type +	Ma	Location *	LS
Category	Earthen Levee			GPS Latitude/Longitude	
				Start	End
Item	Slope Stability			38.061985 °	38.061985 °
				-121.257531 °	-121.257531 °
DWR ID	DWR_NA0017_08_s_2012_49				
Action/Comments					
Repair the levee slope damaged by foot traffic and prevent access where possible.

Slope instability was found due to foot traffic on the landside of the levee looking upstream.

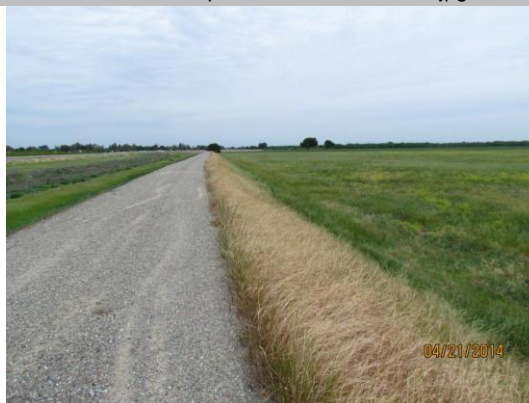
Photo 1 of 1 : pkazi_s_20140428_882.jpg

LM Start	7.68	Rating **	M	Issue No.	57
LM End	7.90	Issue Type +	Ma	Location *	LS
Category	Earthen Levee			GPS Latitude/Longitude	
				Start	End
Item	Vegetation			38.062074 °	38.063815 °
				-121.257370 °	-121.254043 °
DWR ID	DWR_NA0017_08_s_2014_57				
Action/Comments					
Control annual grass and weeds on the levee slopes and easements.

Vegetation on the landside of the levee looking upstream.

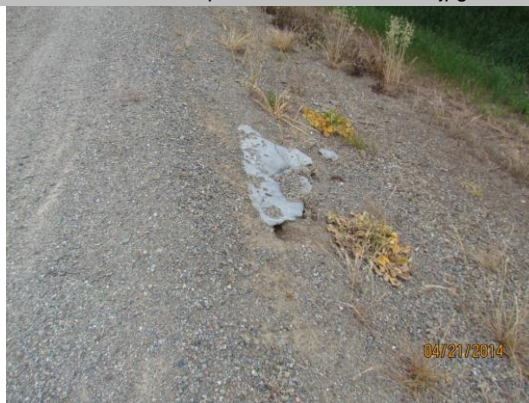
Photo 1 of 1 : pkazi_s_20140428_883.jpg

LM Start	8.82	Rating **	M	Issue No.	67
LM End	8.82	Issue Type +	Ma	Location *	LS
Category	Earthen Levee			GPS Latitude/Longitude	
				Start	End
Item	Animal Control			38.066988 °	38.066988 °
				-121.238857 °	-121.238857 °
DWR ID	DWR_NA0017_08_s_2014_67				
Action/Comments					
No rodents visible, but rodent burrows visible; need to backfill and compact or grout burrows.

View of a rodent hole on the landside of the levee looking upstream.

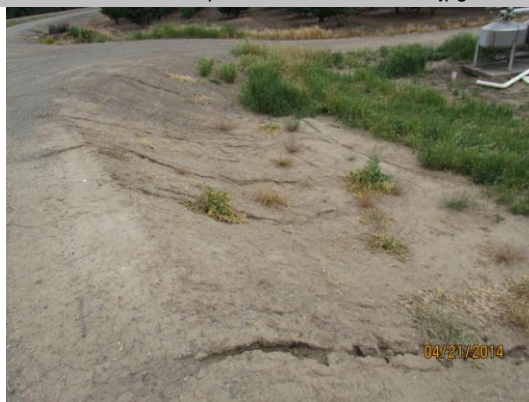
Photo 1 of 3 : pkazi_s_20140428_884.jpg

LM Start	9.48	Rating **	M	Issue No.	92
LM End	9.48	Issue Type +	Ma	Location *	LS
Category	Earthen Levee			GPS Latitude/Longitude	
				Start	End
Item	Erosion / Bank Caving			38.069436 °	38.069436 °
				-121.227527 °	-121.227527 °
DWR ID	DWR_NA0017_08_f_2012_92				
Action/Comments					
Schedule repair of erosion site prior to the next inspection.

Updated picture of the erosion due to runoff on the landside of the levee looking upstream during spring 2014 inspection.

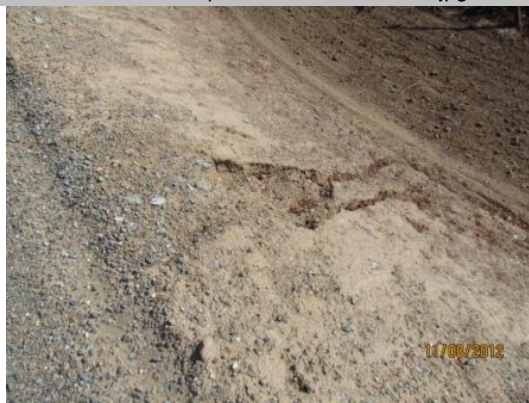
Photo 2 of 3 : pkazi_s_20140415_224.jpg

LM Start	9.48	Rating **	M	Issue No.	92 (cont)	
LM End	9.48	Issue Type +	Ma	Location *	LS	
Category	Earthen Levee			GPS Latitude/Longitude		
				Start	End	
Item	Erosion / Bank Caving			38.069436 °	38.069436 °	
				-121.227527 °	-121.227527 °	
DWR ID	DWR_NA0017_08_f_2012_92					
Action/Comments						
Schedule repair of erosion site prior to the next inspection.

An erosion was found on the landside slope of the levee looking upstream.

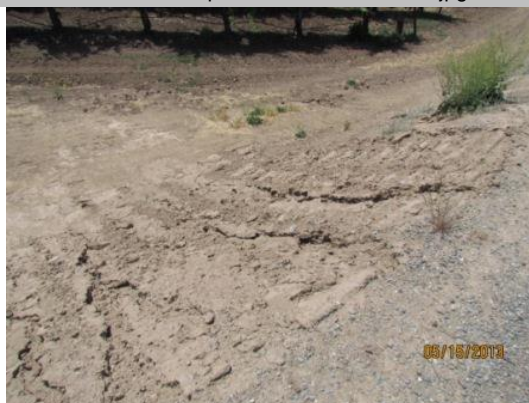
Photo 3 of 3 : pkazi_s_20140415_225.jpg

LM Start	9.48	Rating **	M	Issue No.	92 (cont)
LM End	9.48	Issue Type +	Ma	Location *	LS

Updated picture of the erosion caused by runoff on the landside of the levee looking downstream.

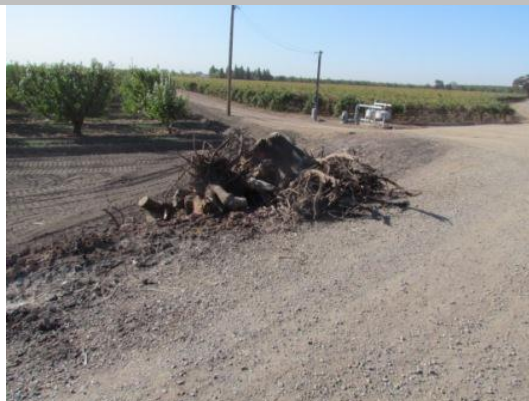
Photo 1 of 1 : pkazi_s_20140415_211.jpg

LM Start	9.52	Rating **	M	Issue No.	55
LM End	9.52	Issue Type +	En	Location *	LS
Category	Earthen Levee			GPS Latitude/Longitude	
				Start	End
Item	Encroachments			38.069625 °	38.069625 °
				-121.226987 °	-121.226987 °
DWR ID	DWR_NA0017_08_s_2012_55				
Action/Comments					
Prunings

Prunings were found on the landside of the levee looking upstream.

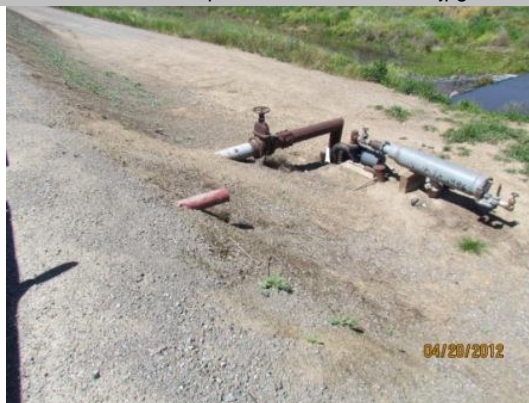
Photo 1 of 1 : pkazi_s_20140415_212.jpg

LM Start	9.75	Rating **	M	Issue No.	56
LM End	9.75	Issue Type +	En	Location *	WS
Category	Earthen Levee			GPS Latitude/Longitude	
				Start	End
Item	Encroachments			38.069786 °	38.069786 °
				-121.222838 °	-121.222838 °
DWR ID	DWR_NA0017_08_s _ 2012_56				
Action/Comments					
Pipe

An open pipe was found on the waterside of the levee looking downstream.

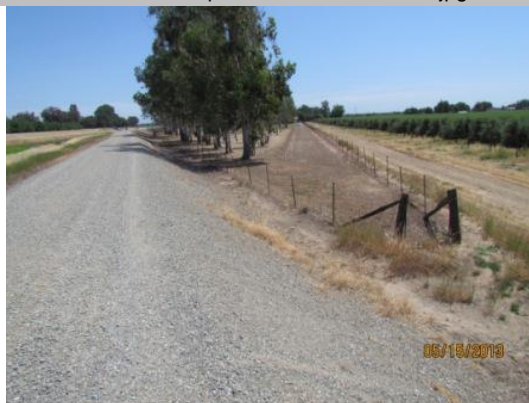
Photo 1 of 1 : pkazi_s_20140415_232.jpg

LM Start	10.23	Rating **	M	Issue No.	950
LM End	10.45	Issue Type +	En	Location *	LS
Category	Earthen Levee			GPS Latitude/Longitude	
				Start	End
Item	Encroachments			38.072622 °	38.073617 °
				-121.215853 °	-121.212182 °
DWR ID	DWR_NA0017_08_s _ 2012_950				
Action/Comments					
Fence

Fence was found on the landside toe of the levee looking upstream.

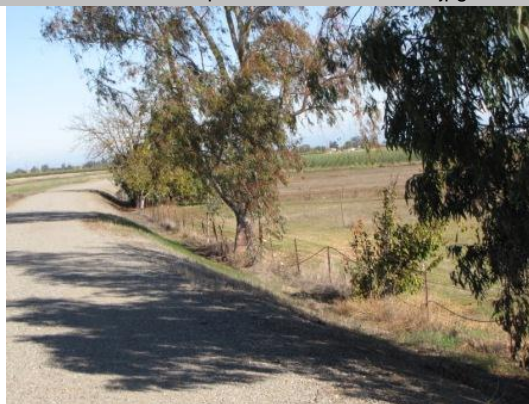
Photo 1 of 1 : pkazi_s_20140415_287.jpg

LM Start	11.47	Rating **	M	Issue No.	1107
LM End	11.64	Issue Type +	En	Location *	LS
Category	Earthen Levee			GPS Latitude/Longitude	
				Start	End
Item	Encroachments			38.081609 °	38.083333 °
				-121.198702 °	-121.196611 °
DWR ID	DWR_NA0017_08_s _ 2012_1107				
Action/Comments					
Fence					
Inspector Comments: Barbed wire fence on landward toe.

View of a fence at the landward toe looking upstream.

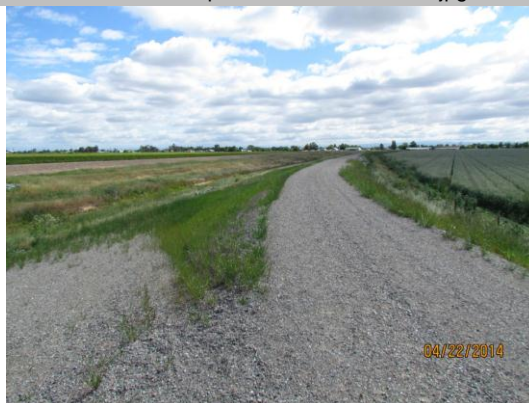
Photo 1 of 1 : pkazi_s_20140428_889.jpg

LM Start	12.07	Rating **	M	Issue No.	74
LM End	12.07	Issue Type +	Ma	Location *	WS
Category	Earthen Levee			GPS Latitude/Longitude	
				Start	End
Item	Erosion / Bank Caving			38.086226 °	38.086226 °
				-121.190051 °	-121.190051 °
DWR ID	DWR_NA0017_08_s_2014_74				
Action/Comments					
Note and monitor erosion site.					
Inspector Comments: Ruts due to runoff

Erosion was found on the waterside of the levee looking upstream.

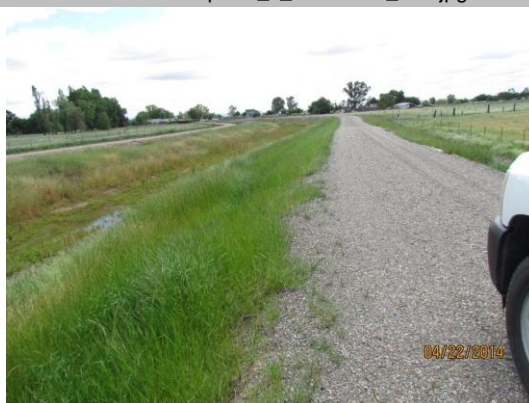
Photo 1 of 1 : pkazi_s_20140428_890.jpg

LM Start	12.46	Rating **	M	Issue No.	76
LM End	12.46	Issue Type +	Ma	Location *	LS
Category	Earthen Levee			GPS Latitude/Longitude	
				Start	End
Item	Animal Control			38.089554 °	38.089554 °
				-121.184999 °	-121.184999 °
DWR ID	DWR_NA0017_08_s_2014_76				
Action/Comments					
No rodents visible, but rodent burrows visible; need to backfill and compact or grout burrows.

Rodent holes were found on the landside slope of the levee looking upstream.

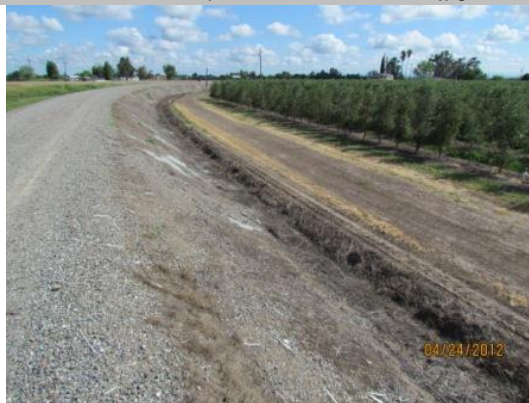
Photo 1 of 1 : pkazi_s_20140415_217.jpg

LM Start	12.49	Rating **	M	Issue No.	66
LM End	12.49	Issue Type +	En	Location *	LS
Category	Earthen Levee			GPS Latitude/Longitude	
				Start	End
Item	Encroachments			38.089971 °	38.089971 °
				-121.184914 °	-121.184914 °
DWR ID	DWR_NA0017_08_s_2012_66				
Action/Comments					
Ditch

An agricultural ditch was found on the landside toe of the levee looking upstream.

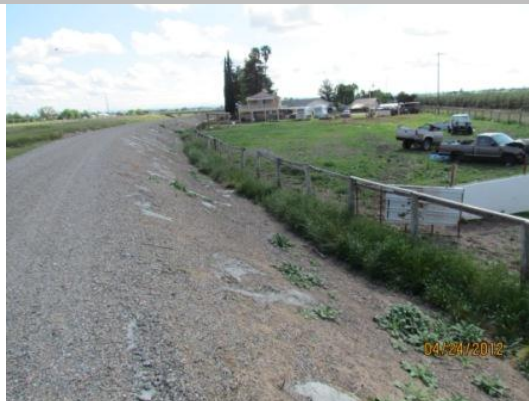
Photo 1 of 1 : pkazi_s_20140415_215.jpg

LM Start	12.60	Rating **	M	Issue No.	61
LM End	12.74	Issue Type +	En	Location *	LS
Category	Earthen Levee			GPS Latitude/Longitude	
				Start	End
Item	Encroachments			38.091226 °	38.091777 °
				-121.184034 °	-121.181578 °
DWR ID	DWR_NA0017_08_s_2012_61				
Action/Comments					
Fence

Fence was found on the landside of the levee looking upstream.

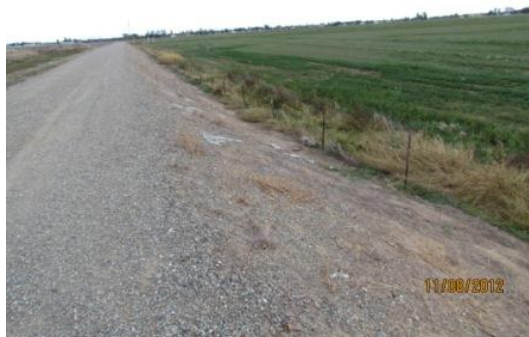
Photo 1 of 1 : pkazi_s_20140415_216.jpg

LM Start	12.77	Rating **	M	Issue No.	62
LM End	13.06	Issue Type +	En	Location *	LS
Category	Earthen Levee			GPS Latitude/Longitude	
				Start	End
Item	Encroachments			38.091814 °	38.093124 °
				-121.181058 °	-121.176383 °
DWR ID	DWR_NA0017_08_s_2012_62				
Action/Comments					
Fence Inspector Comments: Barbed wire fence within 10 feet of the landward toe.

Fence was located on the landside toe of the levee looking upstream.
